# **Schedule of Conservation Works**

**St Luke's Grammar School  
(SSD-10291)**

**800 Pittwater Road, Dee Why and 210 & 224  
Headland Road, North Curl Curl NSW 2099**

AUGUST 2024

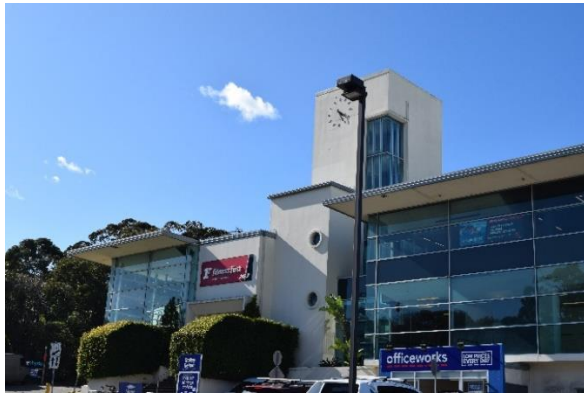
Figure 3: Western façade of the subject building at 800 Pittwater Road, view looking northeast.

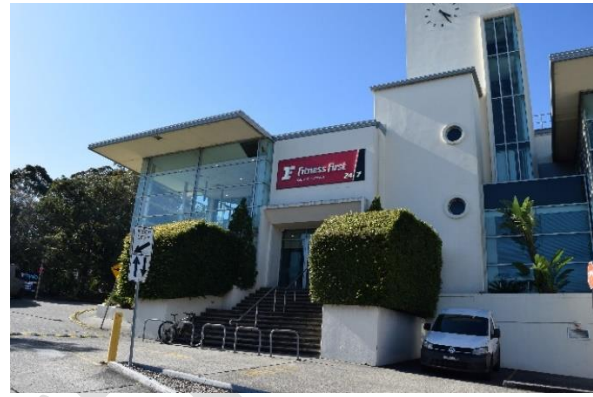
Figure 4: Western façade of the subject building with front entrance and tower, view looking east.

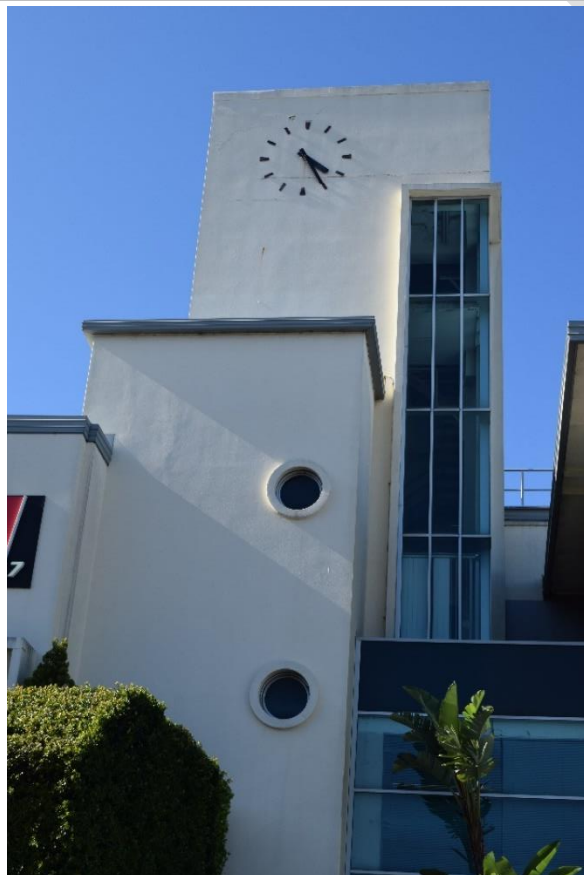
Figure 5: Clock tower (heritage fabric) at the former Wormald Building, view looking east.

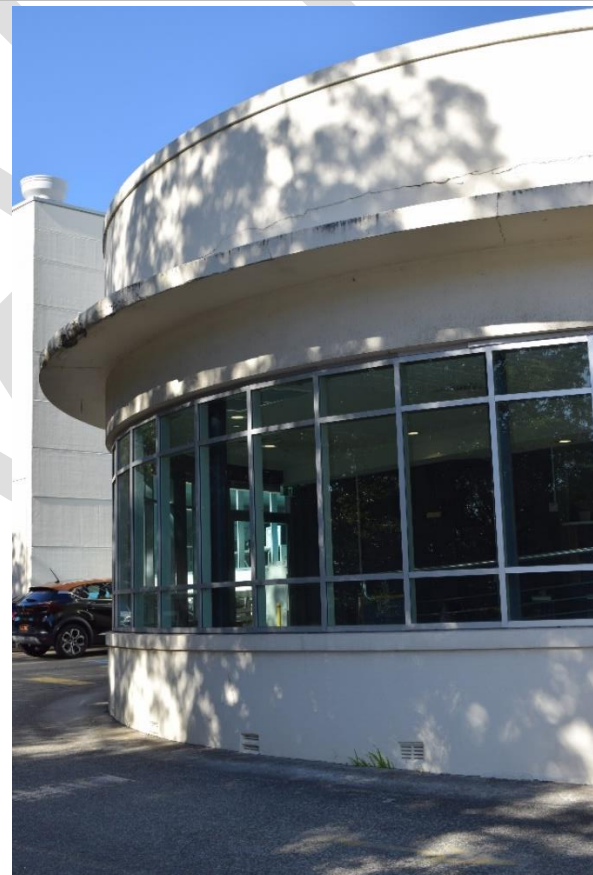
Figure 6: Former curved canteen (heritage fabric) at the former Wormald Building, view looking southeast.

- Patch repair damaged and missing render across the exterior of the building especially the hood of the curved former canteen wing.

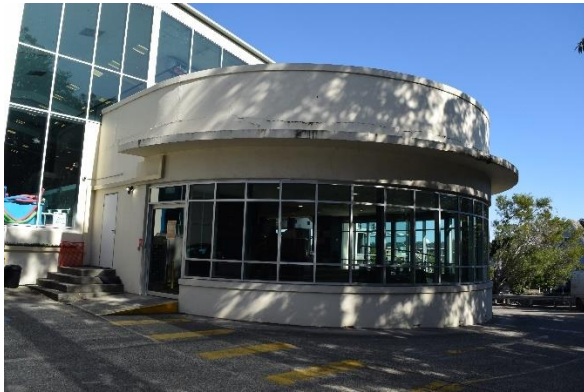
Figure 7: Former curved canteen (heritage fabric) at the former Wormald Building, view looking southwest.

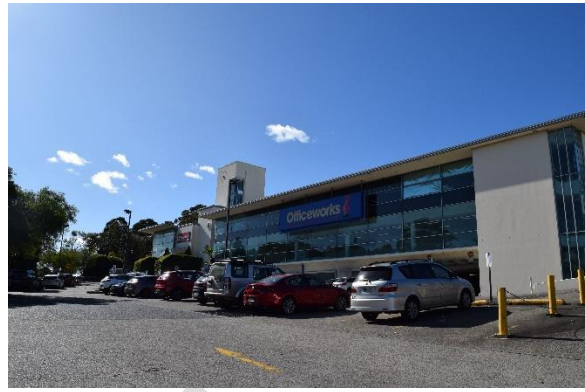
Figure 8: Western elevation of the subject building containing a flat overhanging roof, view looking northeast.

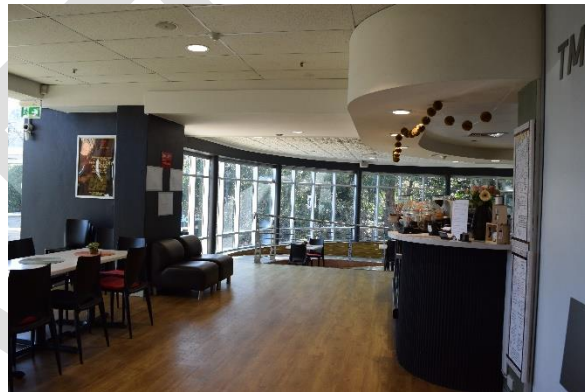
Figure 10: Existing café and seating area in the existing former canteen.

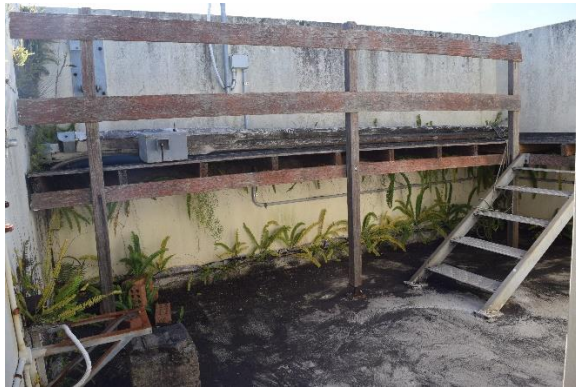
Figure 13: Timber deck at the terrace of Clock Tower.

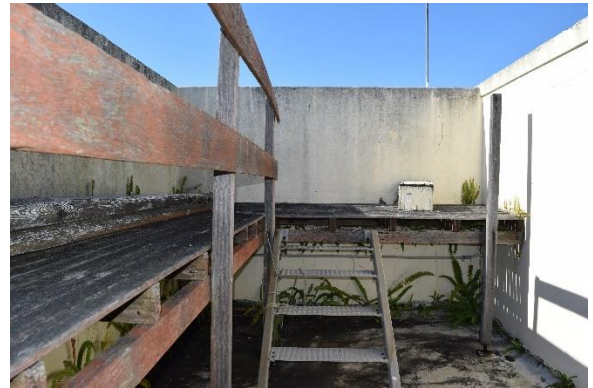
Figure 14: Timber deck at the terrace of Clock Tower.

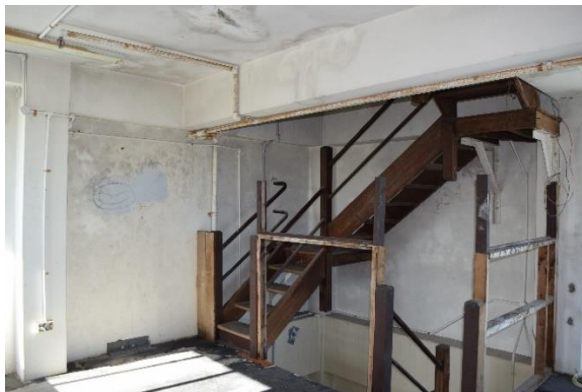
Figure 15: Timber staircase in the Clock Tower.

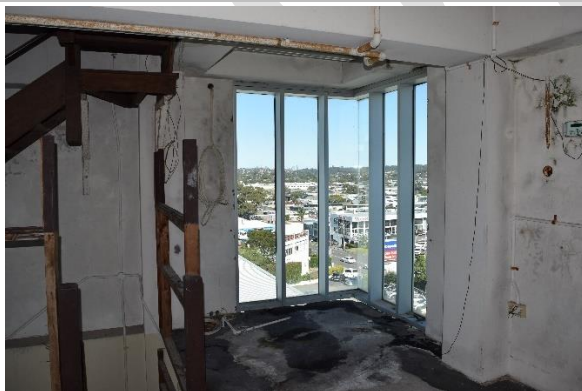
Figure 17: Corner window in the Clock Tower.

INTERIOR			
Joinery	Windows	<ul style="list-style-type: none"> <li>Retain and clean windows. Refurbish as necessary.</li> <li>Service all original hardware.</li> <li>Ensure all glazing is weathertight.</li> </ul>	3.2.9 Doors and Windows 3.2.10 Glazier
Staircase	Timber	<ul style="list-style-type: none"> <li>Retain and make good as necessary.</li> <li>Inspect for any signs of rotting and deterioration in timber staircase and patch repair as necessary.</li> <li>Clean and prepare surface.</li> <li>Repaint. New paint colours to be in consultation with the built heritage specialist.</li> </ul>	3.2.5 Paints and finish coats 3.2.8 Carpentry and joinery
Staircase	Metal balustrade	<ul style="list-style-type: none"> <li>Retain and clean.</li> <li>Check fixings. Repair where required.</li> <li>Repaint. New paint colours to be in consultation with the built heritage specialist.</li> </ul>	3.2.5 Paints and finish coats 3.2.7 Metal worker

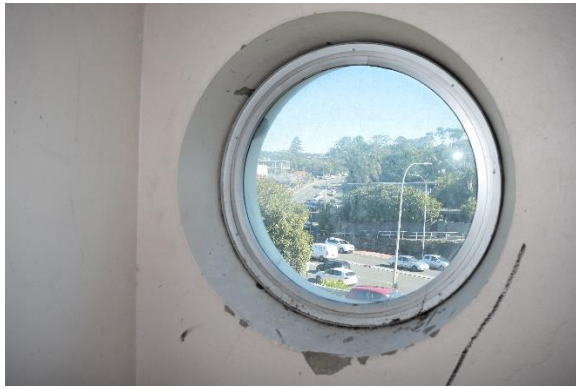
*Figure 19: Existing circular window in the staircase corridor for Clock Tower.*

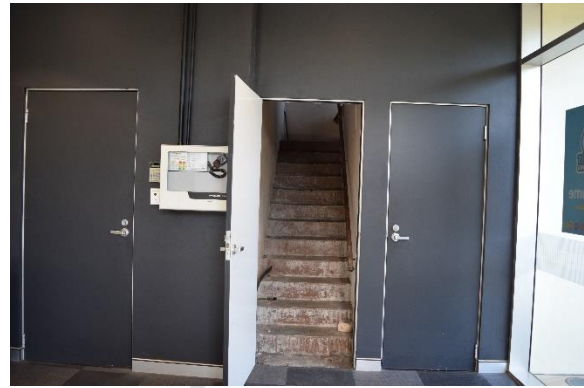
*Figure 20: Entrance to the staircase corridor for Clock Tower.*

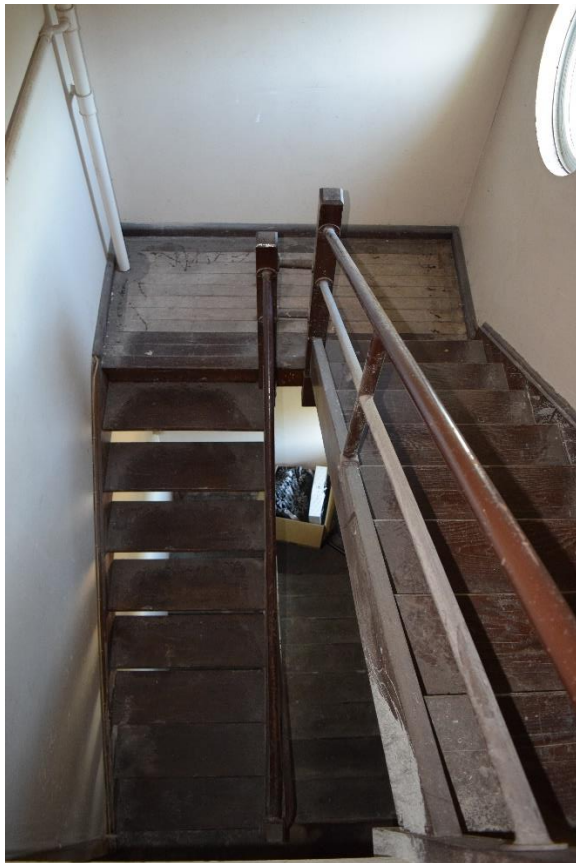
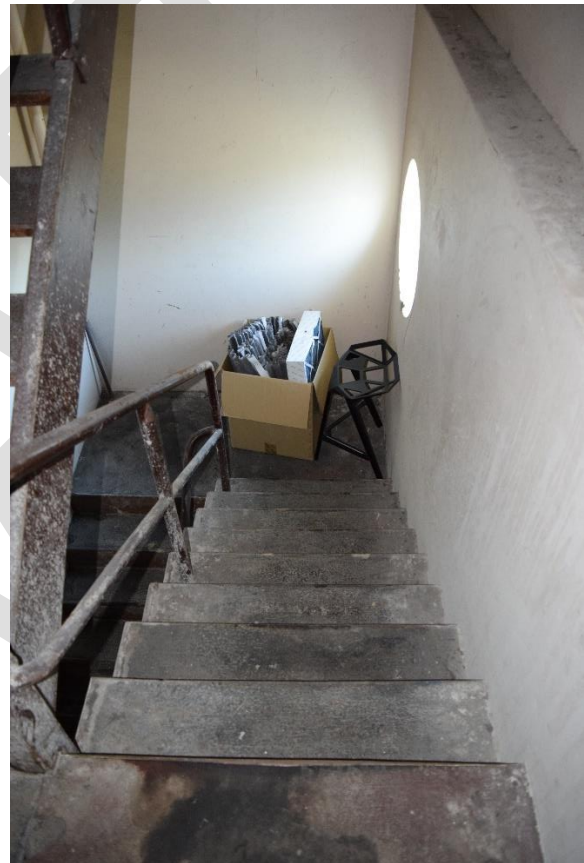
*Figure 21: Staircase corridor leading to the Clock Tower.*

*Figure 22: Staircase corridor leading to the Clock Tower.*
